# **How major incidents can drive safety, sustainability and profitability: Lessons from the U.S. Chemical Safety Board**

**Kristen M. Kulinowski, Ph.D.**  
**Board Member and**  
**Interim Executive Authority**

**Green Chemistry & Engineering**  
**Conference**  
**June 13, 2019**

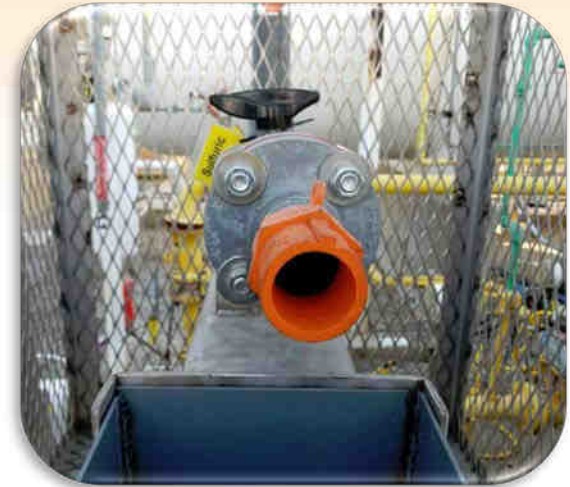
*New coupling on the sulfuric acid fill line  
(Source: MGPI)*

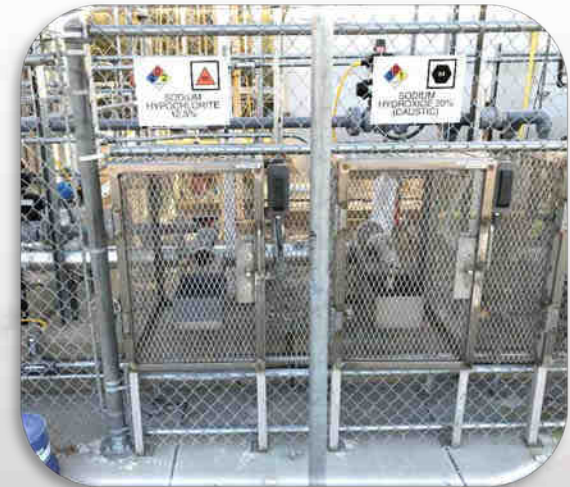
*Separation of unloading connections with secure cages  
around connection points (Source: MGPI)*

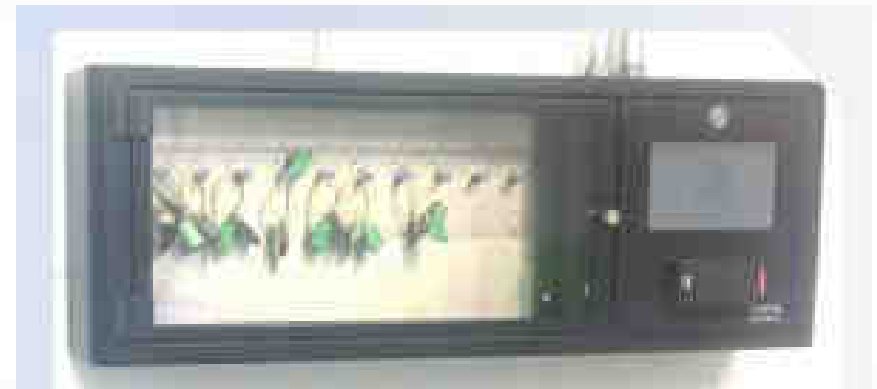
*New key fob lockout system (photo courtesy of MGPI)*

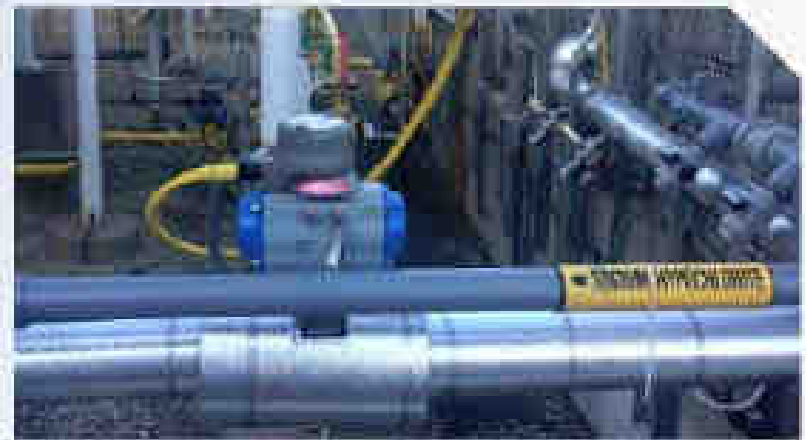
*New shutoff valve (photo courtesy of MGPI)*

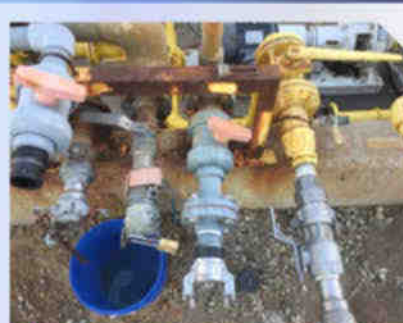
**BEFORE:** Old unloading portals (photo courtesy of CSB)

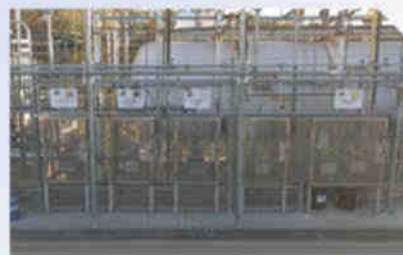
**AFTER:** New unloading portals with magnetic key fob access (photo courtesy of MGPI)
